US Army Corps
of Engineers®
Portland District

Monitoring & maintaining coastal structures at NWP

USACE Coastal CoP meeting

17 May 2006

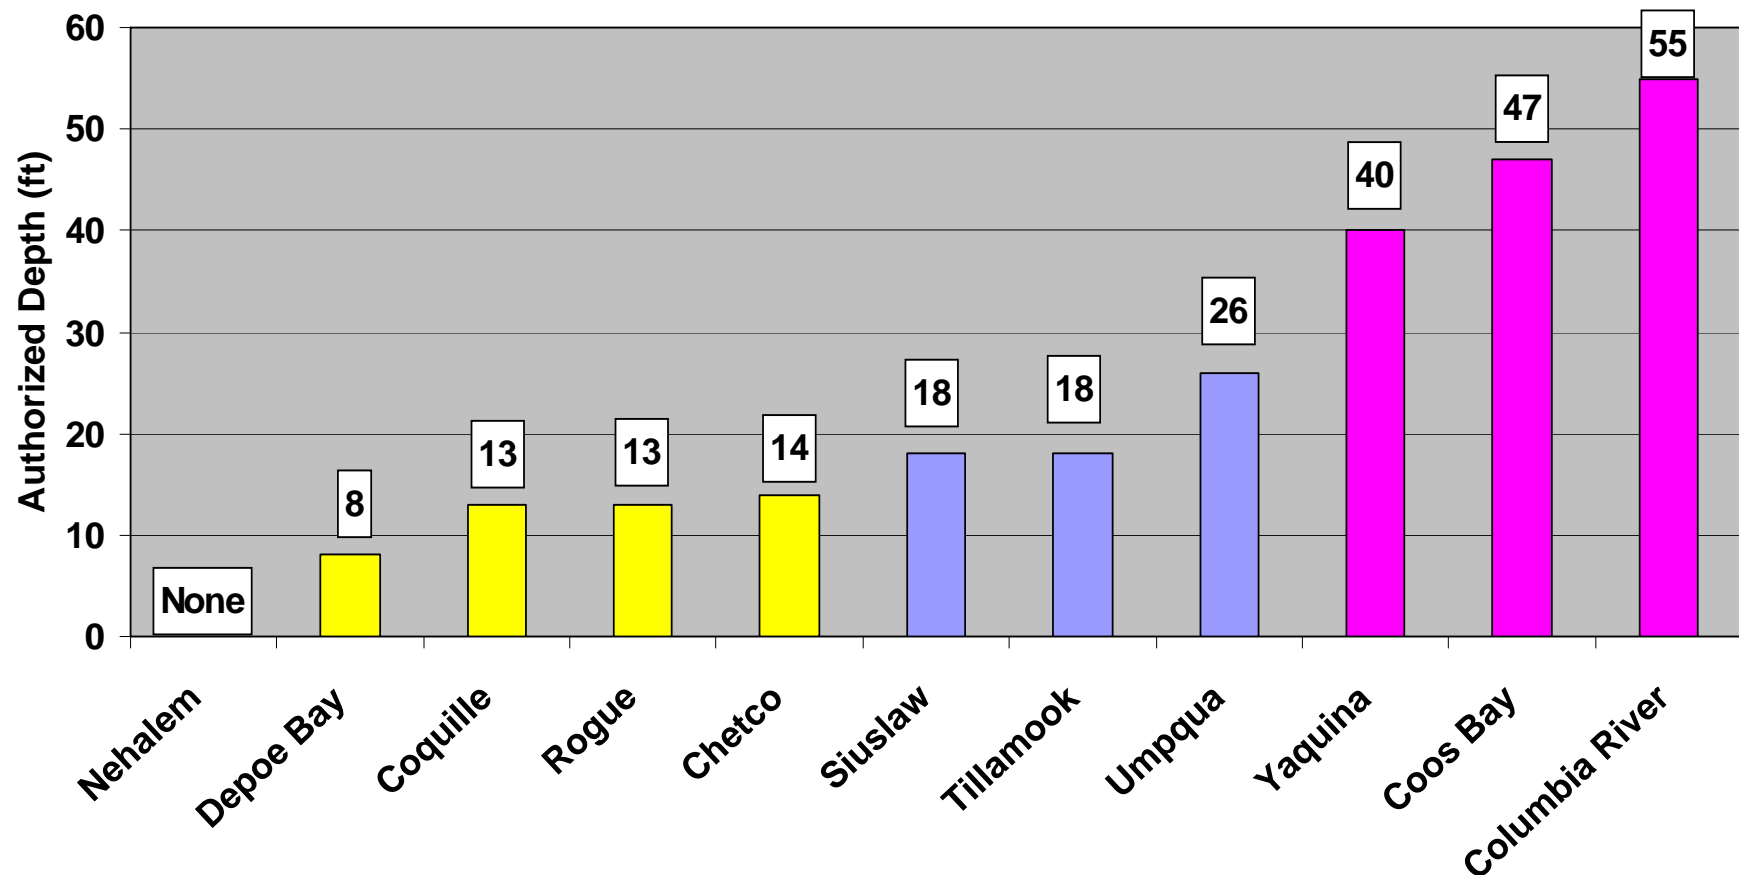
Authorized channel depths (entrance)

While > 50% would be classified as “deep” draft by Corps guidelines, majority fall into small port classification in terms of vessel usage and economic output.

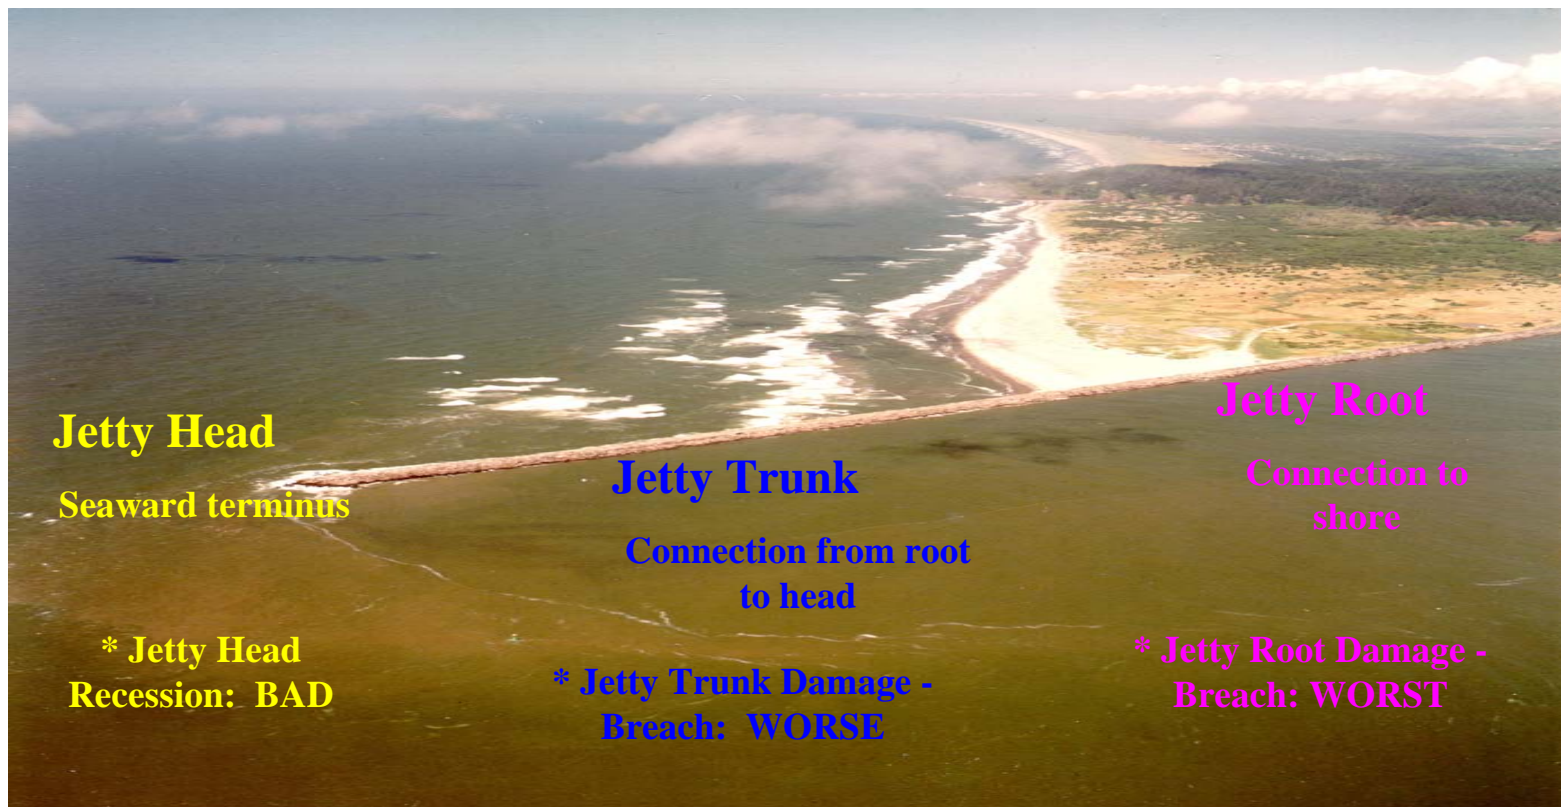
Fig. Components of damage & triggers for significance of damage

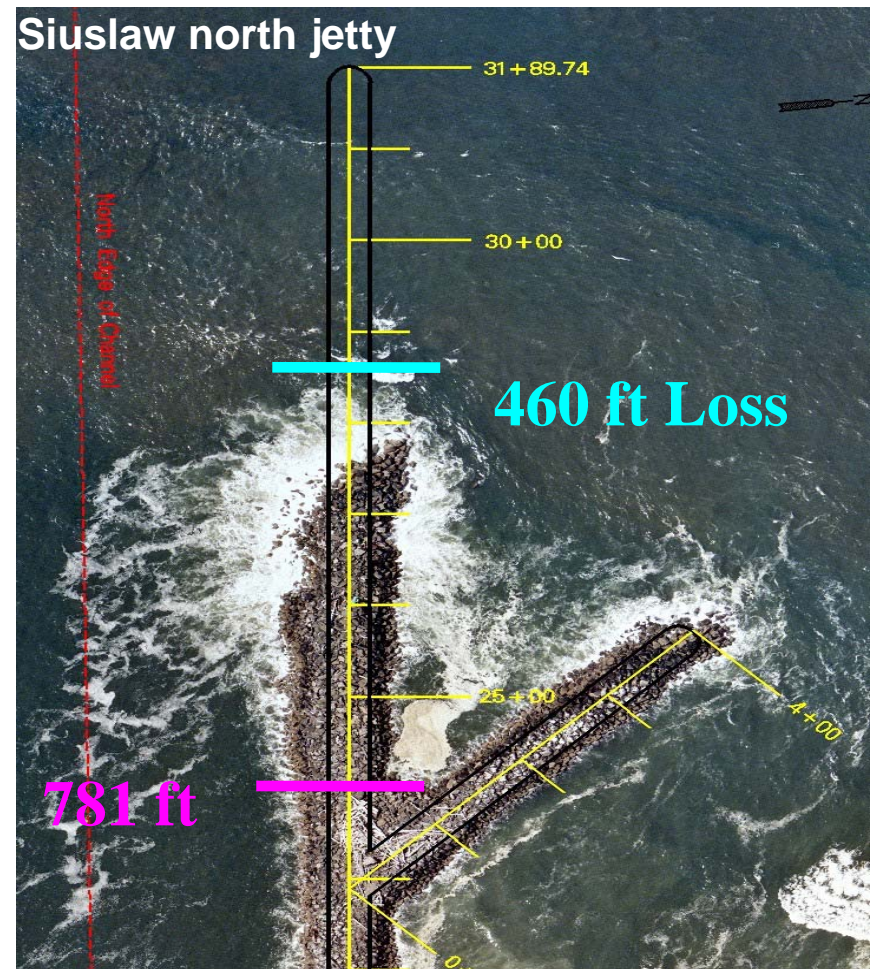
Fig. Present & projected (2010) head positions

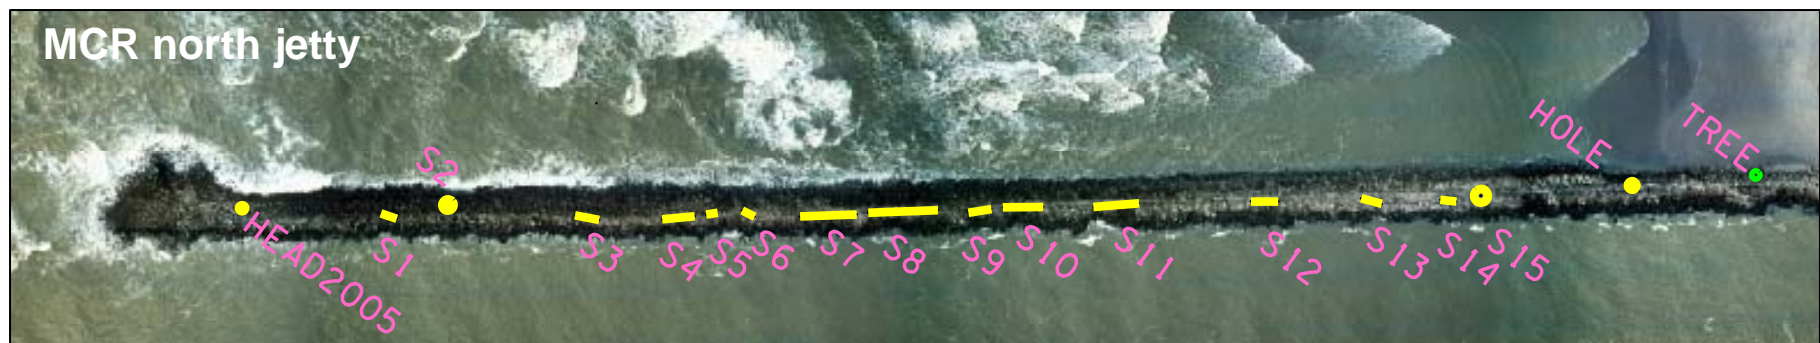
Fig 1. Identify coordinates of jetty head and damage areas with handheld GPS

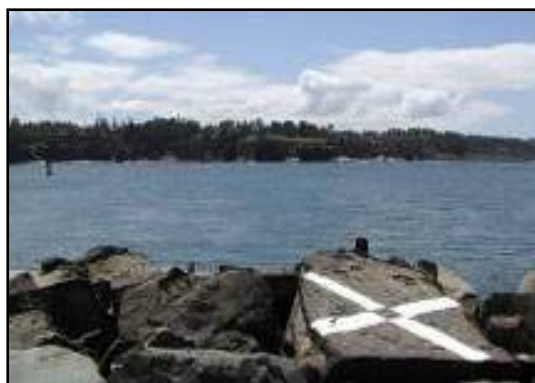
Fig 2. Target/control points for aerial photography

MCR North Jetty (6/05 Inspection)	
GPS Pts.	Description
TREE	Tree located on north side of crest near shoreline
HOLE	Large hole in sideslope on ocean side
S15	channel side scallop
S14	channel side scallop
S13	channel side scallop
S12	channel side scallop
S11	channel side scallop
S10	large scallop on both sides (worst section outside of 2004 interim repairs)
S9	channel side scallop
S8	channel side scallop
S7	channel side scallop
S6	channel side scallop
S5	channel side scallop
S4	channel side scallop
S3	channel side scallop
S2	ocean side scallop
S1	channel side scallop
HEAD2005	jetty head

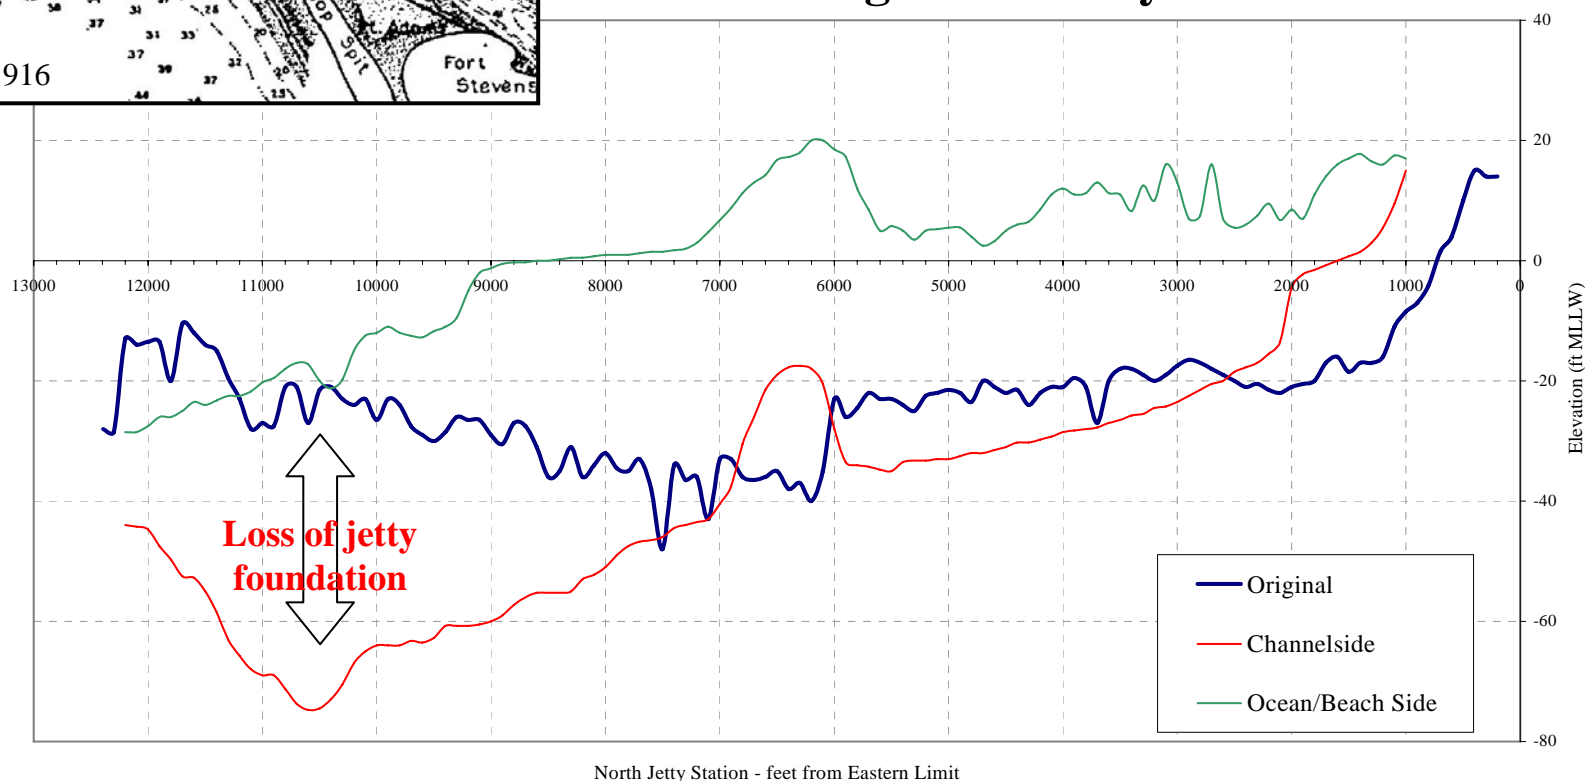
Profile along North Jetty Toe

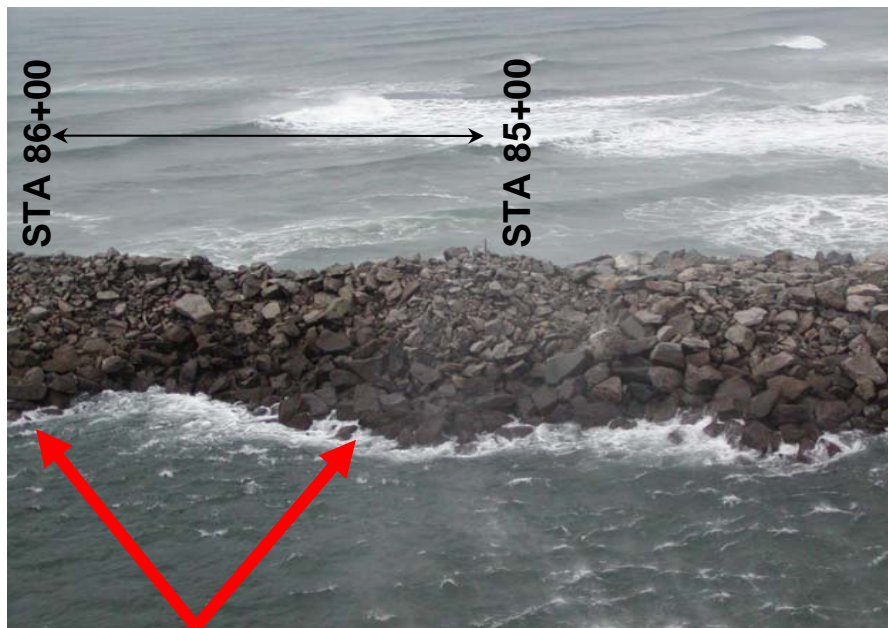
Fig 1. Oblique photography linked to survey

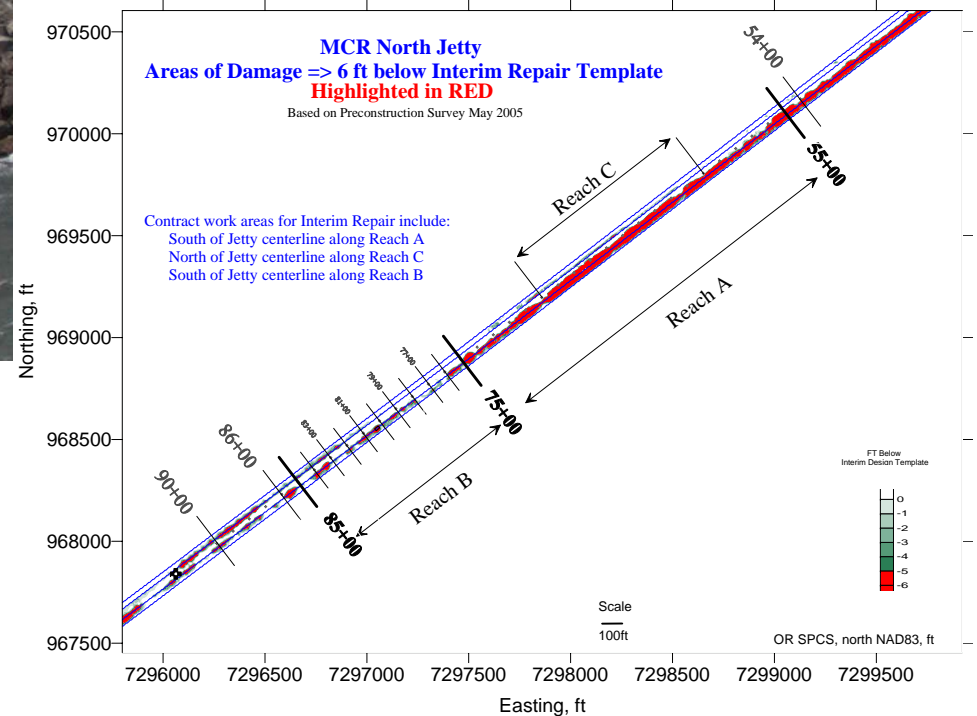
Fig 2. Photogrammetric & Hydro surveys
